Manhole Inspection Summary

Manhole # S33A__021MH

Insp Date: **5/28/09 4:07 PM**

Location Address: **600 CATHREDAL ST**

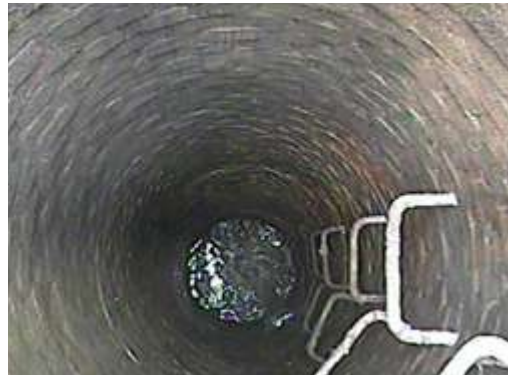
Top View

Comments **Pipe too big to show the connectivity from top view**

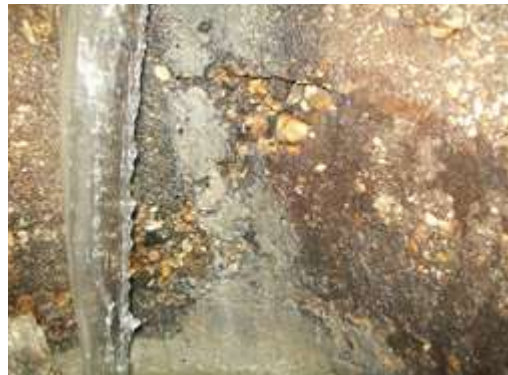
Defect 4

Condition: ☐ Sound ☒ **Cracked** ☐ Root Intrusion ☐ Loose Brick ☐ Deteriorated

Infiltration: ☐ None ☐ Joint ☒ **Cracks** ☐ Mortar ☐ Roots ☐ Wall

DETERIORATED CHIMNEY

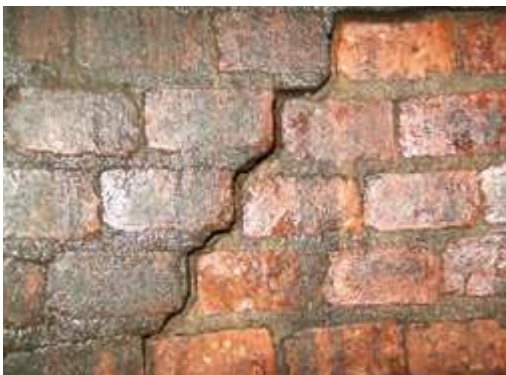
Defect 3

Condition: ☐ Sound ☐ Cracked ☐ Root Intrusion ☐ Loose Brick ☒ **Deteriorated**

Infiltration: ☐ None ☐ Joint ☐ Cracks ☐ Mortar ☐ Roots ☒ **Wall**

deteriorated and infiltration in barrel

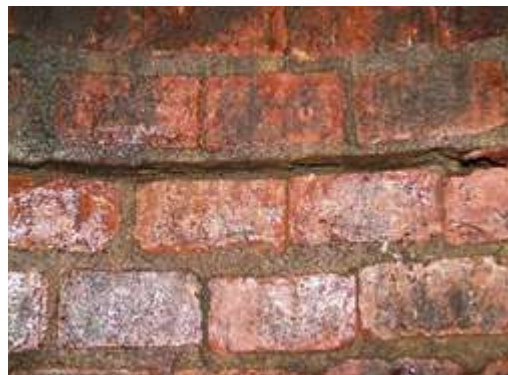
Defect 2

CRACKed and infiltration in CHIMNEY

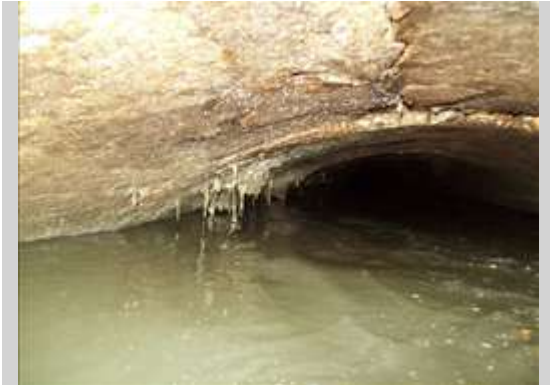
12 O'Clock Outflow

72 in. Circular Gravity Sewer
Pipe Out @ 12 O'Clock

Deposits: ☐ None ☒ Mud ☒ Sludge ☒ Debris ☐ Grease

Silt Depth: **28** (in.) Deposits Extent: **Light**

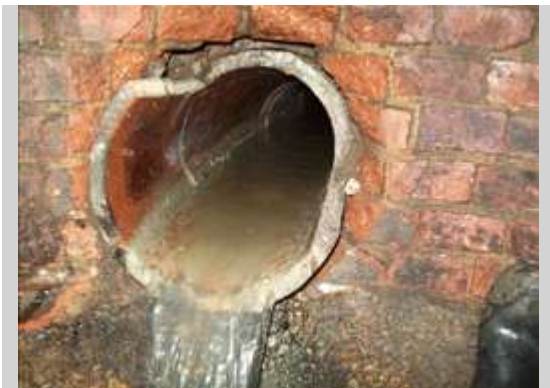
5 O'Clock Inflow

10 in. Circular Gravity Sewer
Pipe In @ 5 O'Clock

Infiltration: **Evidence**

Pipe Seal Cond: **Cracked**

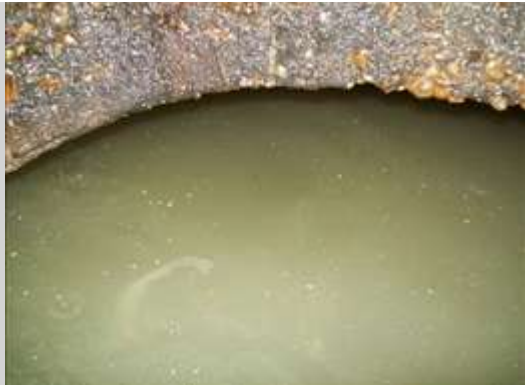
6 O'Clock Inflow

72 in. Circular Gravity Sewer
Pipe In @ 6 O'Clock

Deposits: ☐ None ☐ Mud ☐ Sludge ☒ **Debris** ☐ Grease

Silt Depth: **28** (in.) Deposits Extent: **Light**
